Manhole Inspection Summary

Manhole # S05WW1014MH

Insp Date: **9/12/06 11:16 AM**

Location Address: **5720 SULGRAVE AVE**

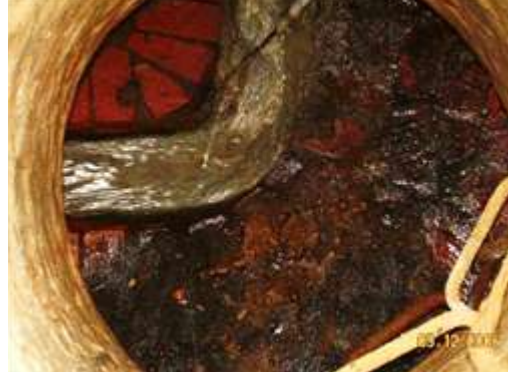
Top View

Corroded steps. Evidence of surcharge - Bench debris.

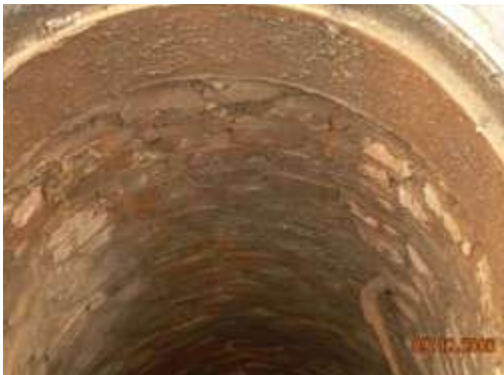
Defect

Frame leaks. Adjustment deterioration and infiltration. Corbel and Barrel infiltration. Corroded steps.

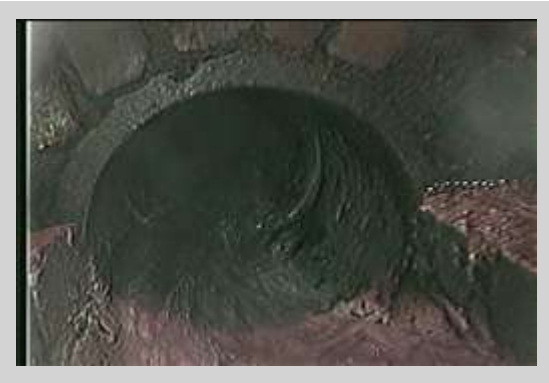
10 in. Circular Gravity Sewer Pipe Out @ 12 O'Clock

Infiltration: **None** Pipe Seal Cond: **Cracked**

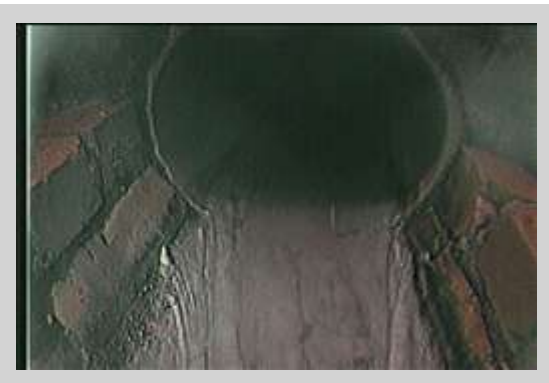
10 in. Circular Gravity Sewer Pipe In @ 9 O'Clock

Bench and Channel deterioration.

Infiltration: **Evidence** Pipe Seal Cond: **Unknown**
